PRESERVATION PLAN AND RECOMMENDATIONS FOR THE COLEMAN-LEIGH-WARREN CEMETERY, AUGUSTA, GEORGIA

Chicora Research Contribution 483

Prepared By:
Michael Trinkley, Ph.D.
Debi Hacker
and
Nicole Southerland

January 2008

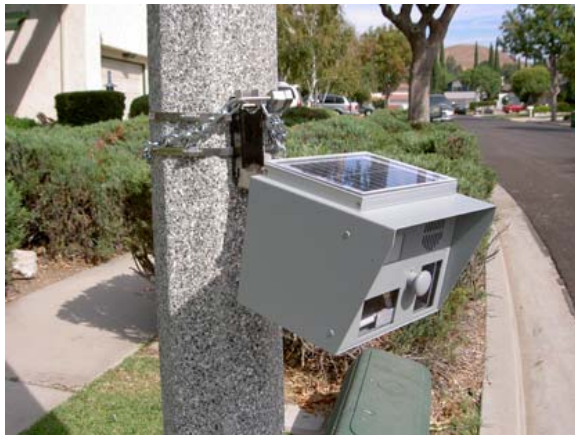
(<http://www.qstartech.com>). This self-contained digital system is motion activated; a photograph is taken (a flash unit allows night photographs at 100 feet), and a customized recorded announcement is played. Units are solar powered, eliminating the need for

Figure 13. Example of the Q-Star Flashcam 880.

electrical connections. Photographs are high resolution and time/dated stamped. Units can be downloaded wirelessly. Although not inexpensive, they are among the most affordable solutions for cemeteries facing on-going vandalism and theft problems.

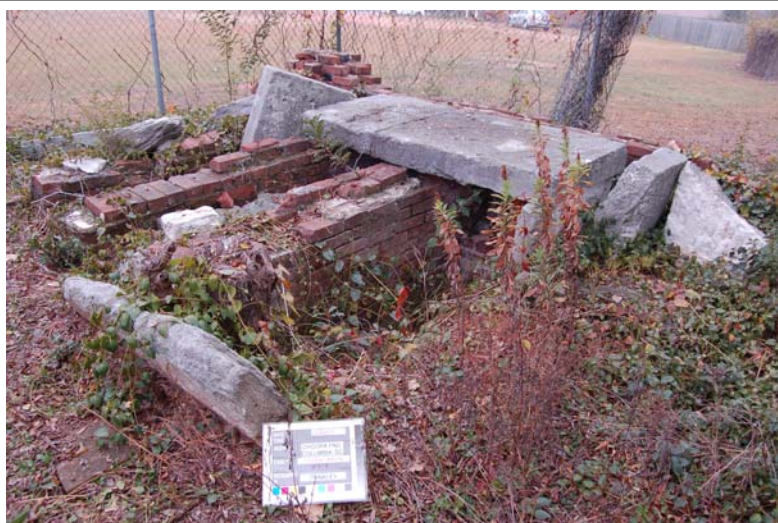
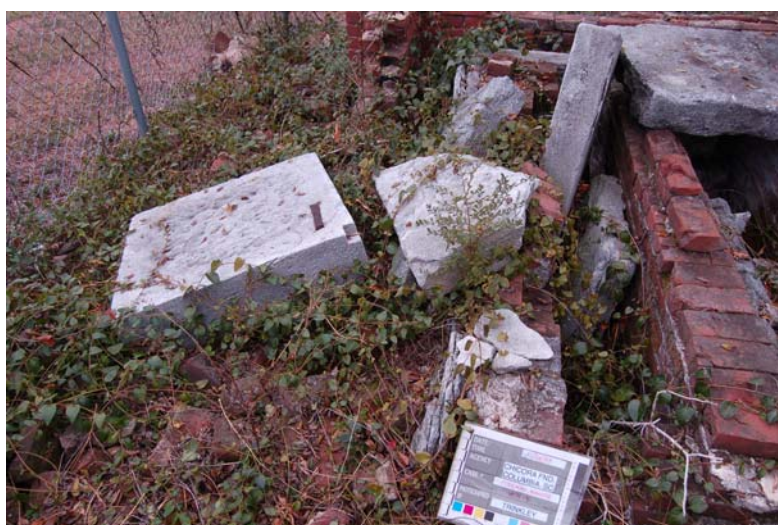
Figure 18. Box tomb of the Leigh Family (4-6).

All but one of the six single box are single wythe. The one exception has double wythe head and foot, with single wythe side walls. Consequently, each box will require approximately 150 brick, of which perhaps only 50 are currently present, leaving a deficit of approximately 600 brick.

Until such funds are available, we recommend preparing a simple marble slab with the names of the Leigh family originally interred in the three box tombs and erect it on top of the rebuilt boxes. This would ensure that the graves

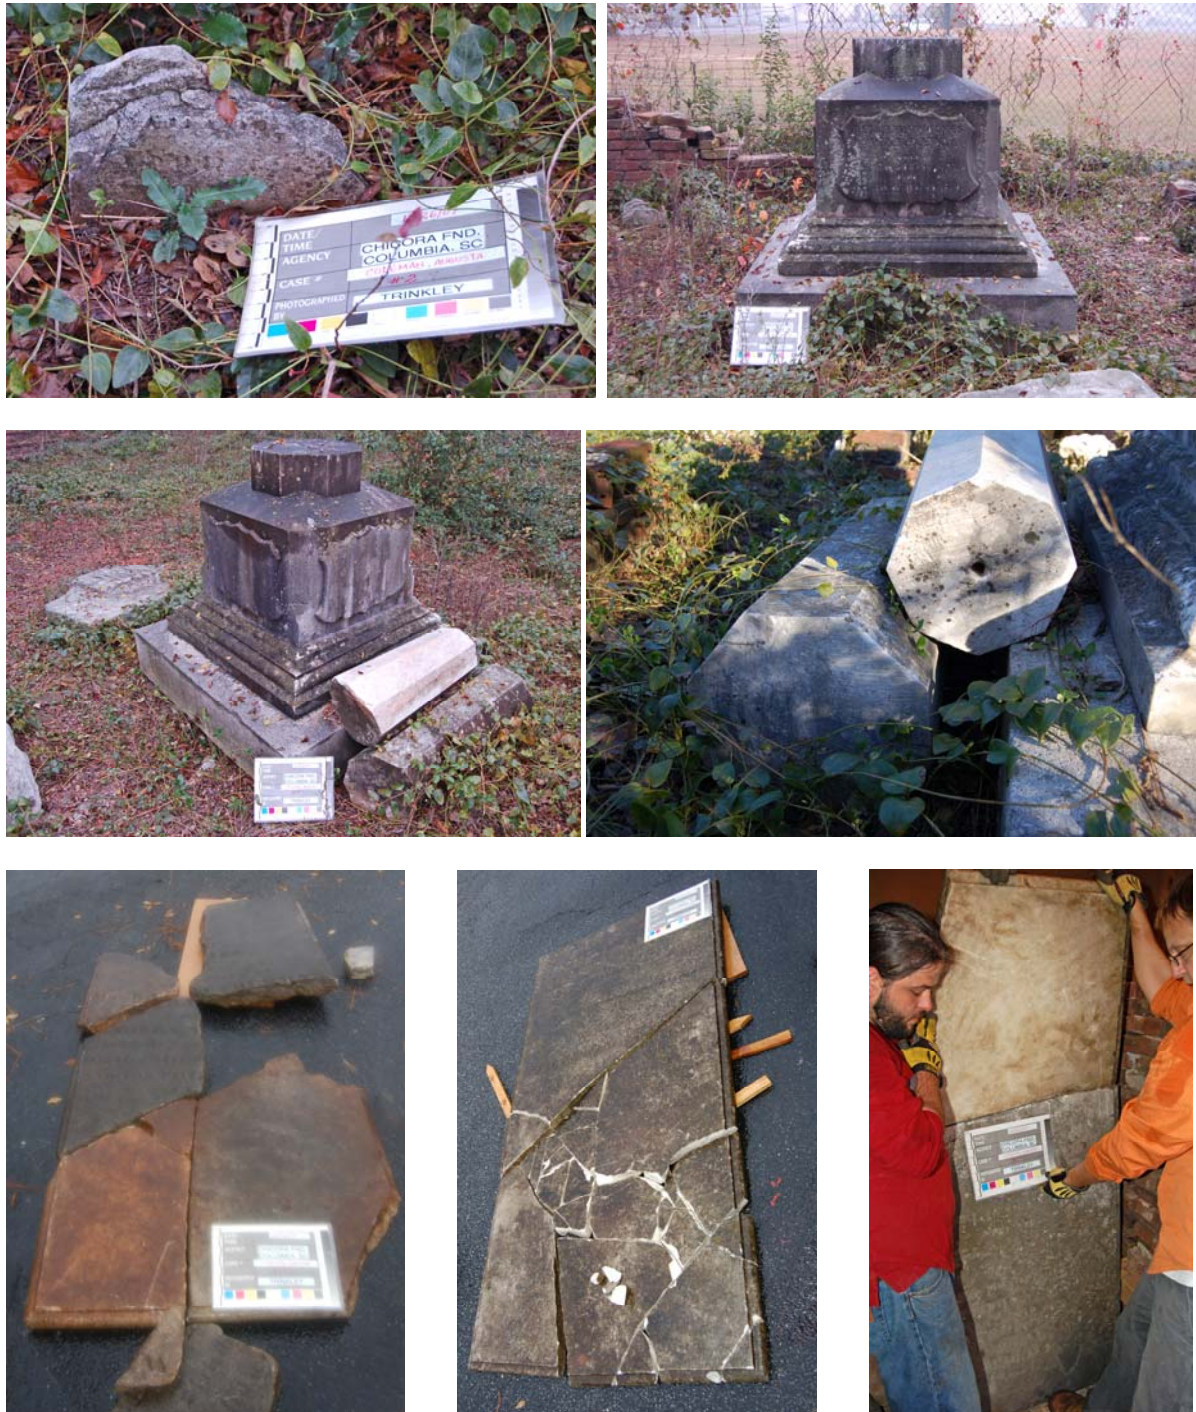
Figure 19. Marble monuments from the Coleman-Leigh-Warren Cemetery. For upper left to lower right: 2 - Walter Leigh Warren; 3, Warren monument - front, oblique, and close-up of the broken column; 11, Sarah Coleman; 7, William H. Warren; 10, Lindsay Coleman.
